Thank you for purchasing the PG-FP5 flash memory programmer.

This document describes specifications that have been added or changed, restrictions, and cautions on using the PG-FP5. Also see the user's manual of the PG-FP5 for cautions on using the PG-FP5.

Chapter 1 Product Version

Chapter 2 Additions and Changes to Specifications

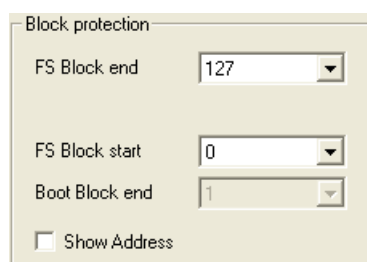
No. 16 Change of layout in **Block protection** area

Description: The layout in the **Block protection** area has been changed.

Implementation: This item has been implemented in products with control code A (firmware: V2.02, FPGA: V2, GUI: V2.02).
